750 #32
8/9/71

SERVICE BULLETIN

AMERICAN HONDA MOTOR CO., INC. MOTORCYCLE SERVICE DEPARTMENT

CB-750 RECALL FOR DRIVE SYSTEM MODIFICATION

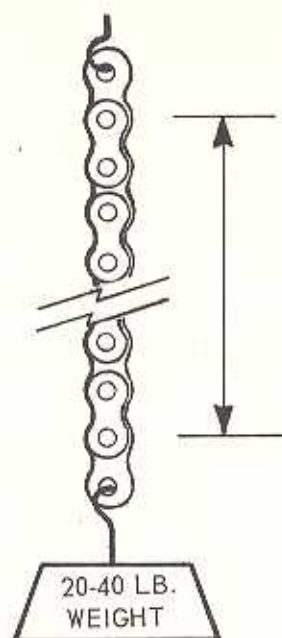
DRIVE CHAIN USED WITH CB-750, FRAME NUMBERS
CB750-1000001 THROUGH CB750-1044649:

97 LINKS (96 PINS) WITH MASTER LINK REMOVED.

SERVICE LIMIT 60 9/16", MEASURED FROM FIRST
PIN TO LAST PIN.

Straighten any stiff joints. Then measure chain length while chain is hung with a 20 to 40 lb. weight attached to the lower end. This procedure will ensure that the chain is fully extended when measured.
